Roof Inspection Report

JR Management
Agave & Rye
479 N High St
Columbus, OH 43215

Section: Agave & Rye

Inspection Date: 08/31/2022

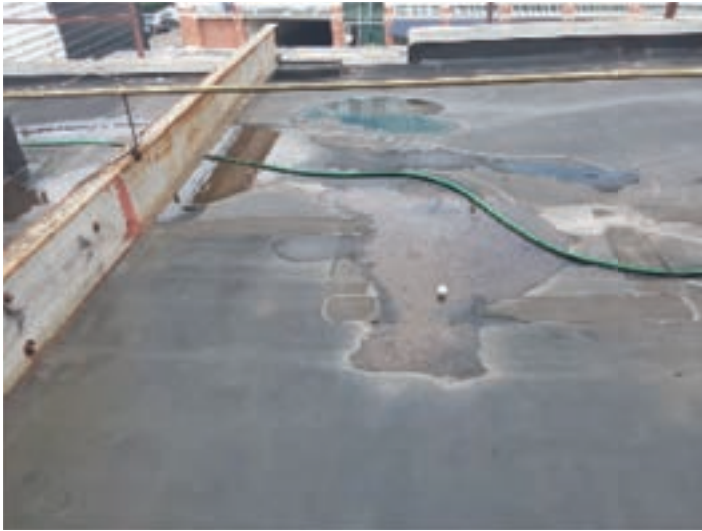
Ponding water

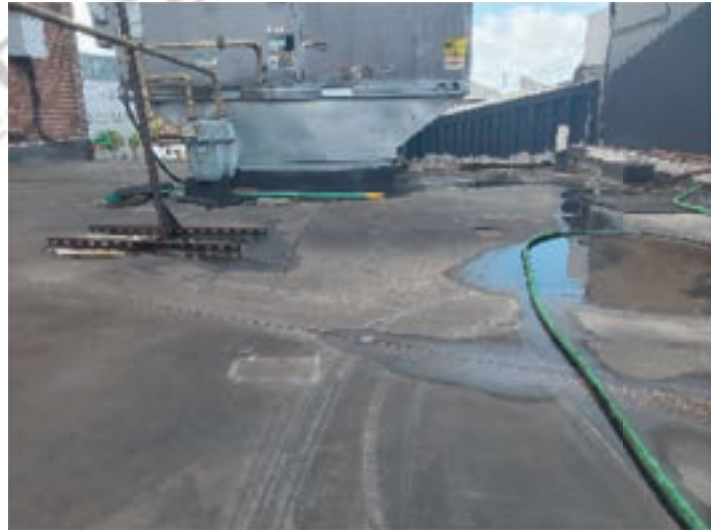
Heaved Insulation

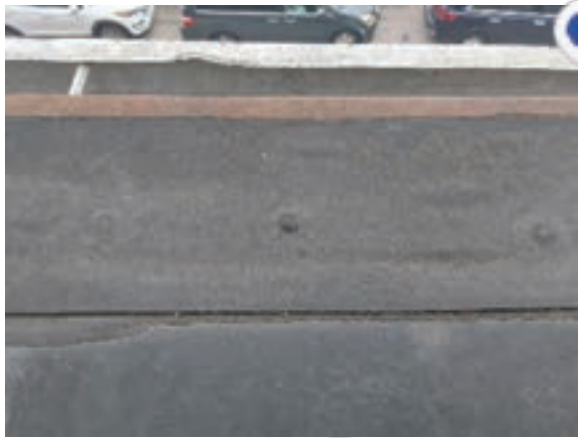
Perimeter - Strip in failure (Emergency)

Roof membrane has separated from metal edge. If the strip in is failing it can allow water to infiltrate and damage the roof system, deck and building interior.

Remove the loose membrane, secure metal edge joint, clean and prime metal and install new material that extends 3" onto roof to ensure water tightness.

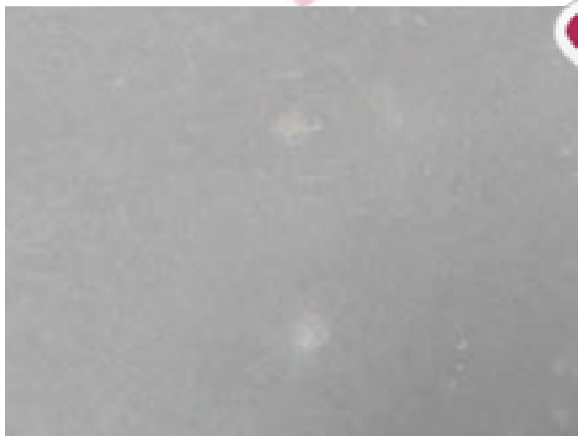
Membrane - Holes (Emergency)

Holes caused by physical damage to the roof surface.

Repair holes as needed.

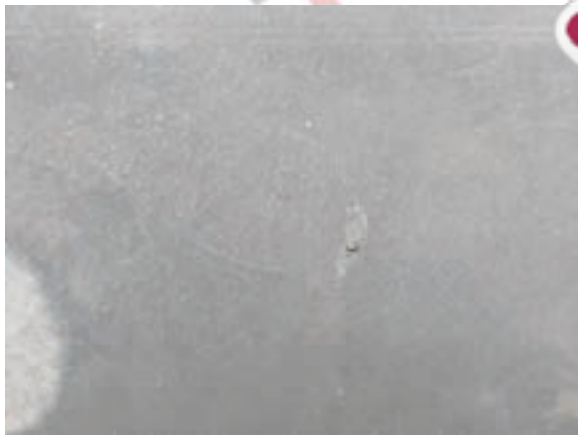
Membrane - Holes (Emergency)

Holes caused by physical damage to the roof surface.

Repair holes as needed.

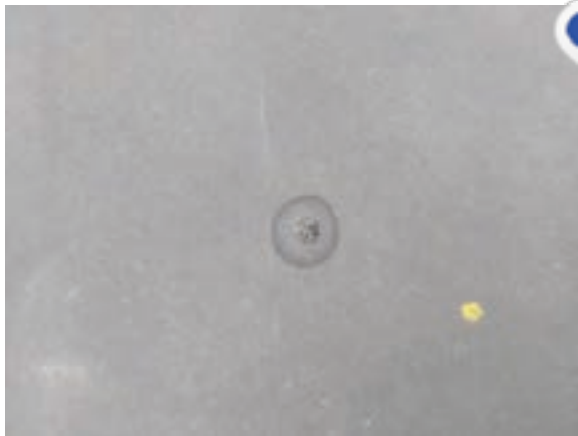
Membrane - Holes (Emergency)

Holes caused by physical damage to the roof surface.

Repair holes as needed.

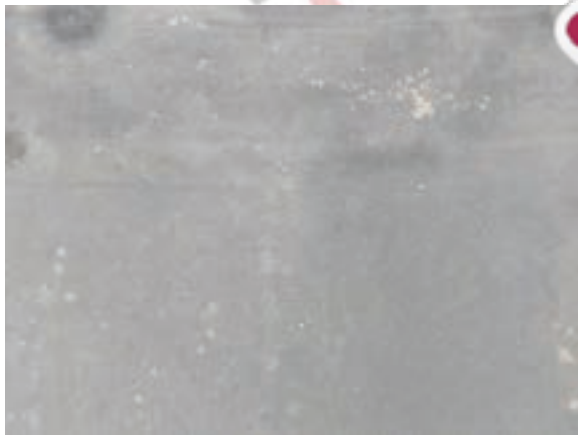
Membrane - Holes (Emergency)

Holes caused by physical damage to the roof surface.

Repair holes as needed.

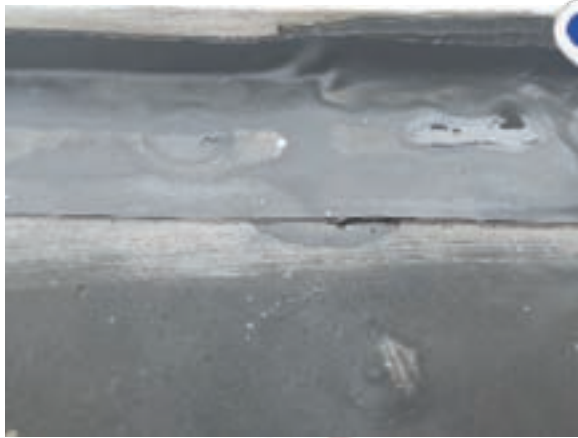
Perimeter - Strip in failure (Emergency)

Roof membrane has separated from metal edge. If the strip in is failing it can allow water to infiltrate and damage the roof system, deck and building interior.

Remove the loose membrane, secure metal edge joint, clean and prime metal and install new material that extends 3" onto roof to ensure water tightness.

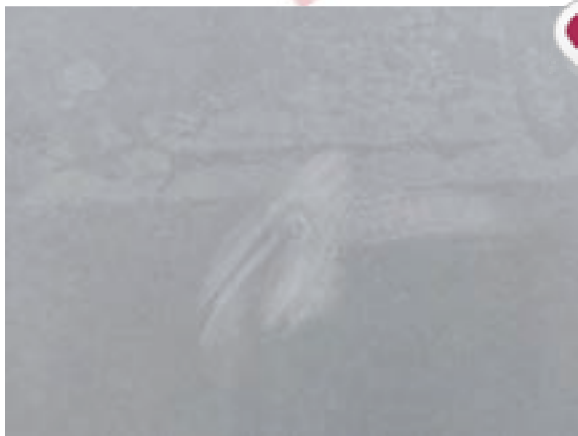
Membrane - Holes (Emergency)

Holes caused by physical damage to the roof surface.

Repair holes as needed.

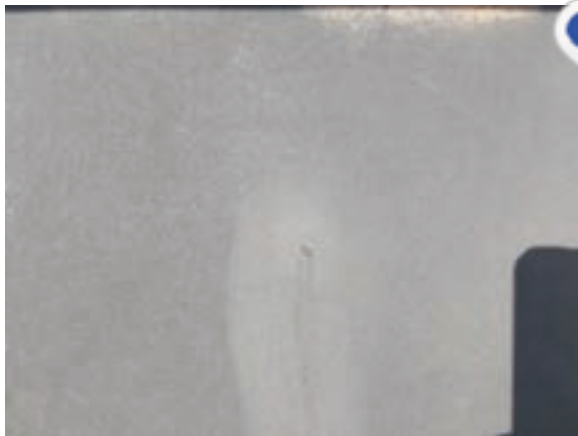
Membrane - Holes (Emergency)

Holes caused by physical damage to the roof surface.

Repair holes as needed.

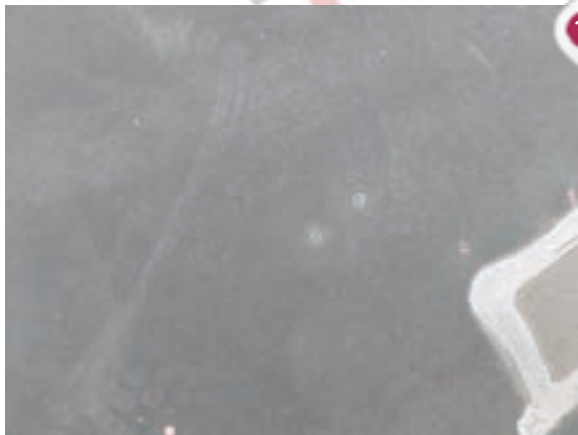
Membrane - Holes (Emergency)

Holes caused by physical damage to the roof surface.

Repair holes as needed.

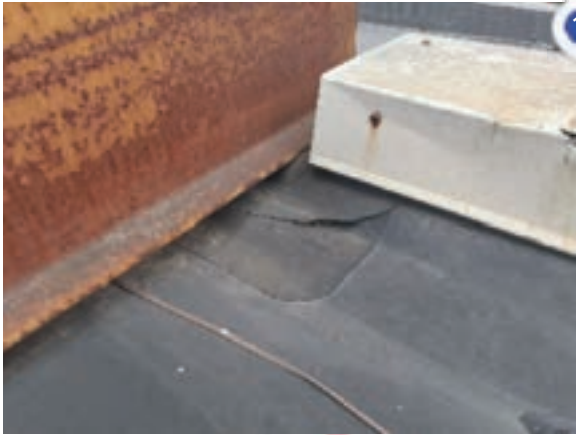
11

Base Flashing - Failure

The existing base flashing has either been damaged or failing due to age, abuse, U.V. degradation or thermal shock.

The existing loose base flashing material should be removed and new matching materials installed as recommended by the manufacturer.

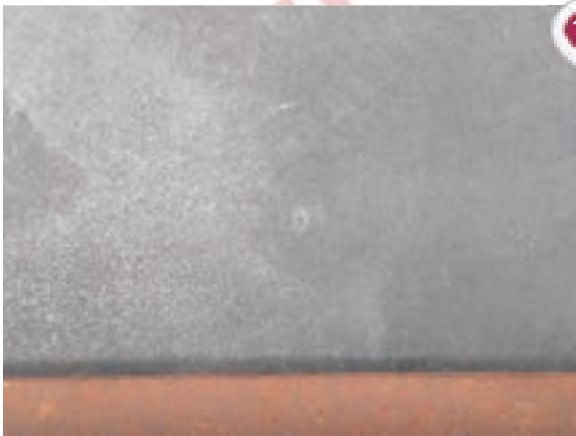
12

Membrane - Holes (Emergency)

Holes caused by physical damage to the roof surface.

Repair holes as needed.

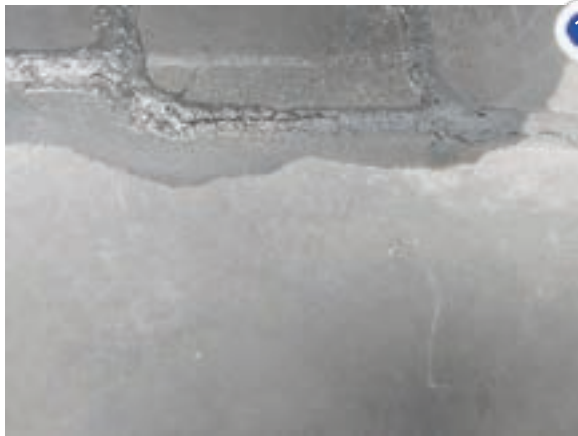
Membrane - Holes (Emergency)

Holes caused by physical damage to the roof surface.

Repair holes as needed.

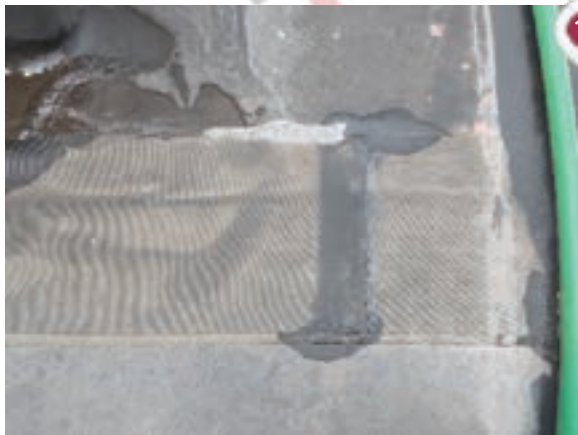
Membrane - Open Flashing

Open flashings can be caused by membrane shrinkage, insufficient counterflashing, or the simple aging and failure of the original flashing.

Depending on the severity, either needs to be removed completely and new flashing installed or the existing flashing must be re-sealed.

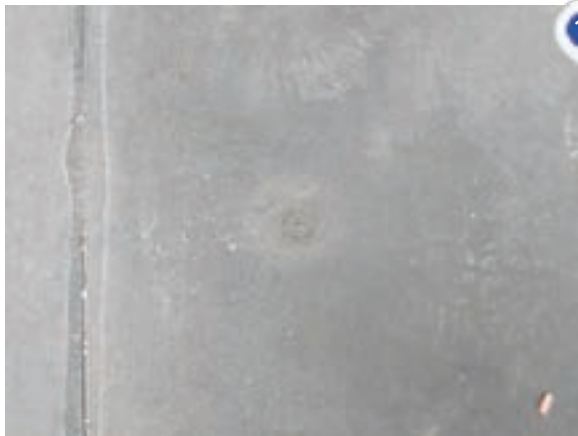
Membrane - Holes (Emergency)

Holes caused by physical damage to the roof surface.

Repair holes as needed.

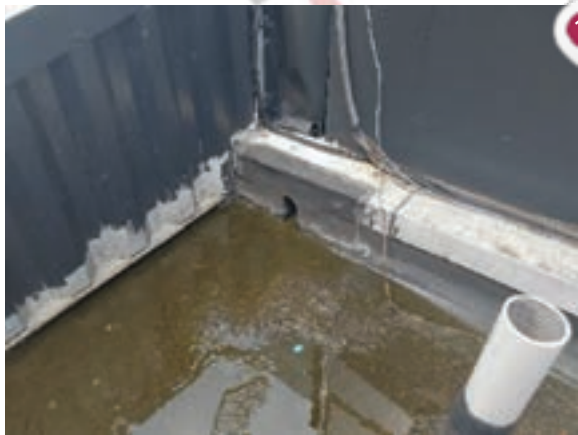
Drainage - Drains/Scupper Open Membrane

Open membrane laps at scupper / drain is open.

We will clean prime and seal open laps to ensure water tightness.

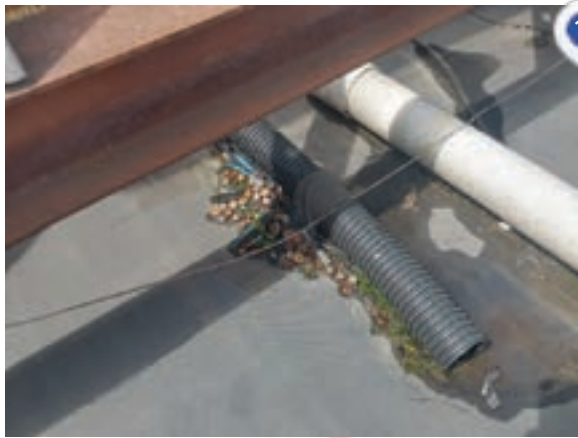
Debris - Trash on Roof

Loose debris has a high probability of blowing around on the roof and causing damage to the waterproofing membrane.

Remove loose debris from roof area and include as part of routine preventative maintenance. Inspect and repair damaged membrane resulting from wind blown debris.

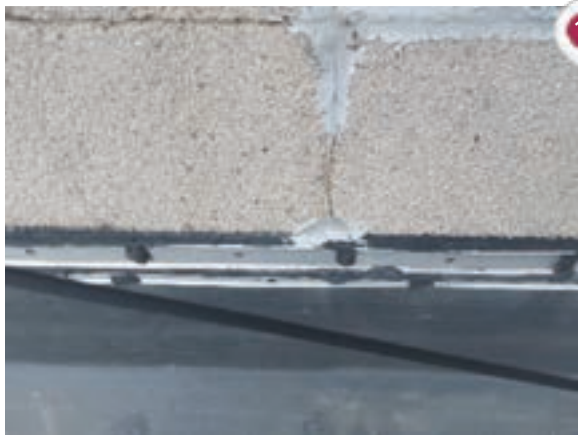
Perimeter - Counter Flashing Caulk Failure (Emergency)

Sealant along counter flashing is failed or failing and allowing water to migrate into the roof system.

Remove the old caulking, wire brush as needed, prime the area and install new sealant tooled to ensure water tightness.

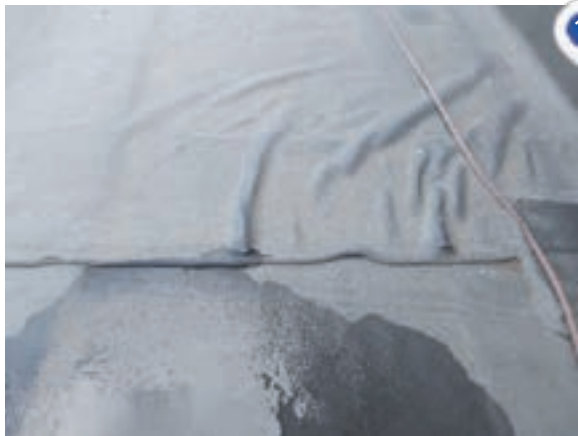
Membrane - Fish Mouth (Emergency)

Example of fish mouths on membrane laps that is allowing water into the system.

We will cut the fish mouth out, clean and prime the area and install new patch over effected area to ensure water tightness.

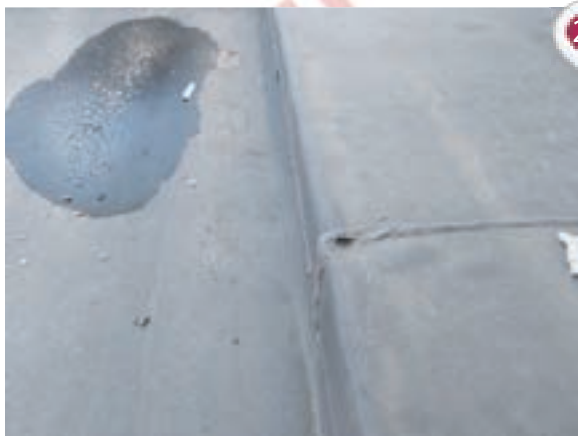
Membrane - Fish Mouth (Emergency)

Example of fish mouths on membrane laps that is allowing water into the system.

We will cut the fish mouth out, clean and prime the area and install new patch over effected area to ensure water tightness.

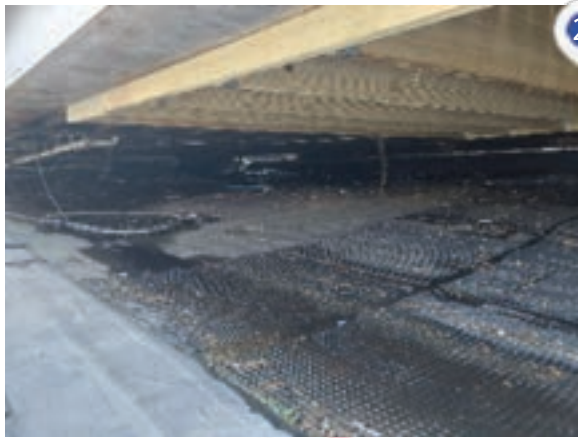
Debris - Trash on Roof

Loose debris has a high probability of blowing around on the roof and causing damage to the waterproofing membrane.

Remove loose debris from roof area and include as part of routine preventative maintenance. Inspect and repair damaged membrane resulting from wind blown debris.

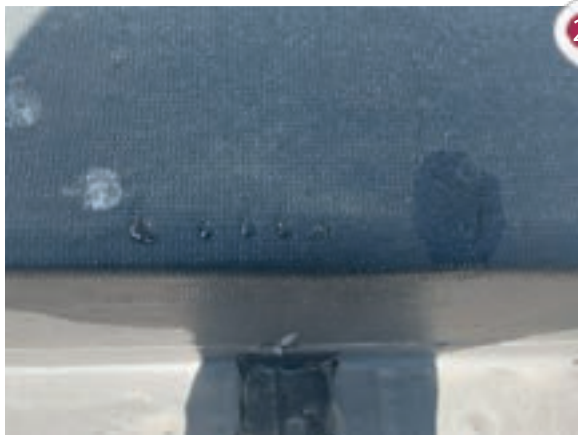
Membrane - Holes (Emergency)

Holes caused by physical damage to the roof surface.

Repair holes as needed.
